MORRIS CANAL GREENWAY

WATER AND THE CANAL

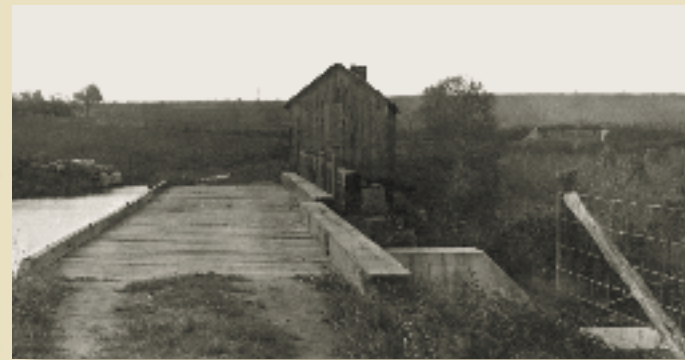
A view looking west down the towpath towards Phillipsburg and across the overflow-waste weir. On the right, in the distance, is the humpback canal bridge over what is now Strykers Road. On the left is a masonry structure where heavy planks could be dropped into a slot acting as a temporary water barrier across the canal prism in case of a break, to drain for maintenance, or to stop navigation at the end of the boating season.

During construction of the canal, Lopatcong Creek was directed into the basin at the bottom of Inclined Plane 9 West where it combined with discharge water from the plane. But because Lopatcong Creek frequently flooded, a small water overflow and a large combined overflow-waste weir were built into the towpath between the bottom of Plane 9 and present day Strykers Road.

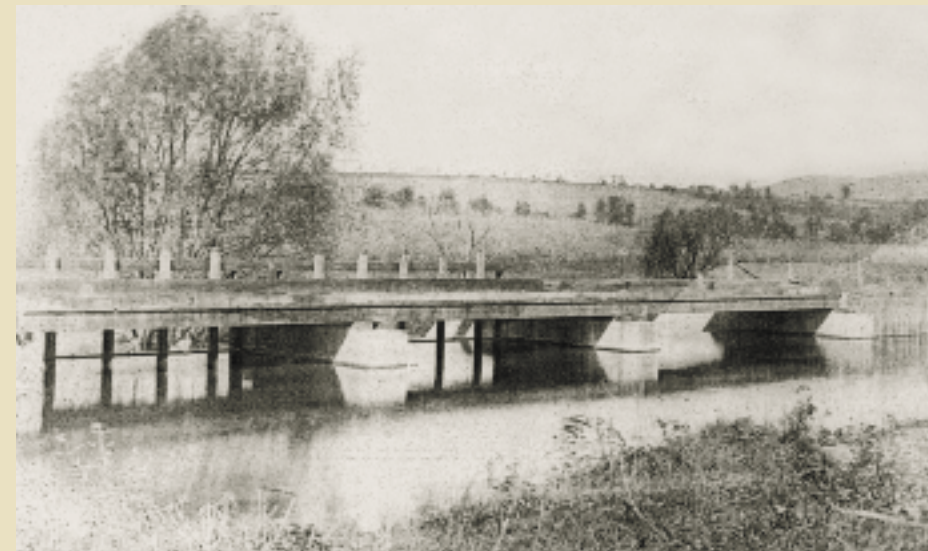
A long bridge carries the canal towpath across the combination overflow-waste weir. The section on the right acted as an overflow allowing excess water to spill back into Lopatcong Creek. In the left background are part of the control mechanisms that operated the waste gates during flooding. At approximately 76 feet, this waste weir was the largest in Warren County.

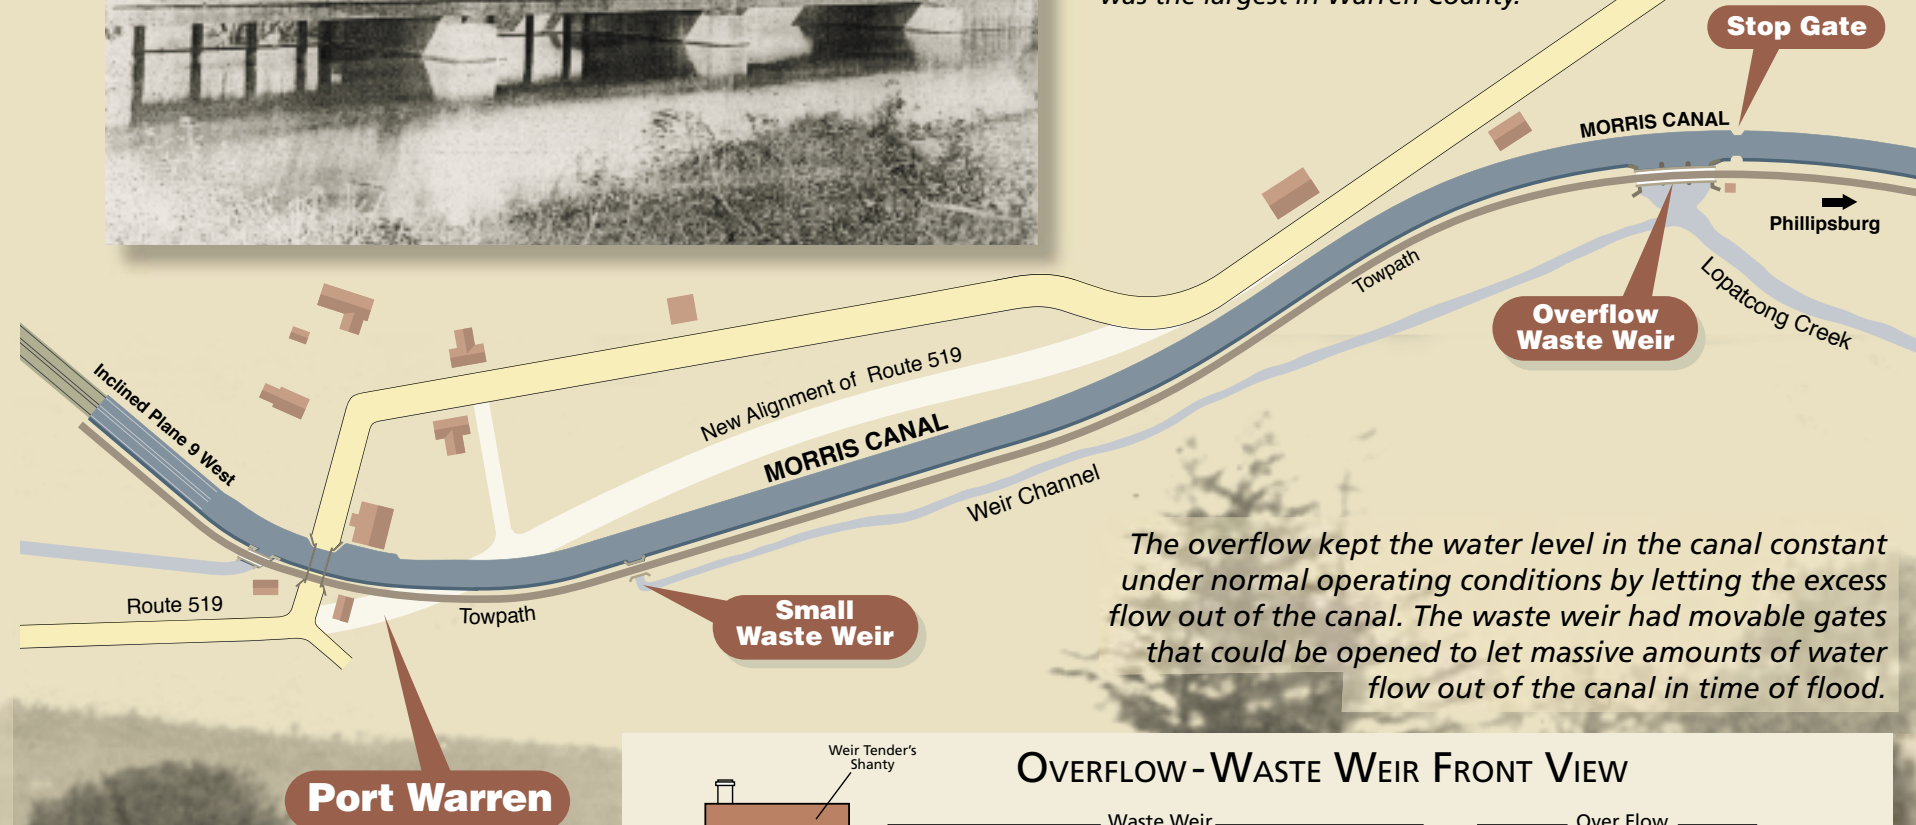
The overflow kept the water level in the canal constant under normal operating conditions by letting the excess flow out of the canal. The waste weir had movable gates that could be opened to let massive amounts of water flow out of the canal in time of flood.
